USAAVLABS TECHNICAL REPORT 69-35

FIELD APPLICATION STUDY AND ENVIRONMENTAL AND BALLISTICS EVALUATION OF VITHANE SEALING MATERIALS

April 1969

**CONTRACT DAAJ02-68-C-0020
THE GOODYEAR TIRE & RUBBER COMPANY
AKRON, OHIO**

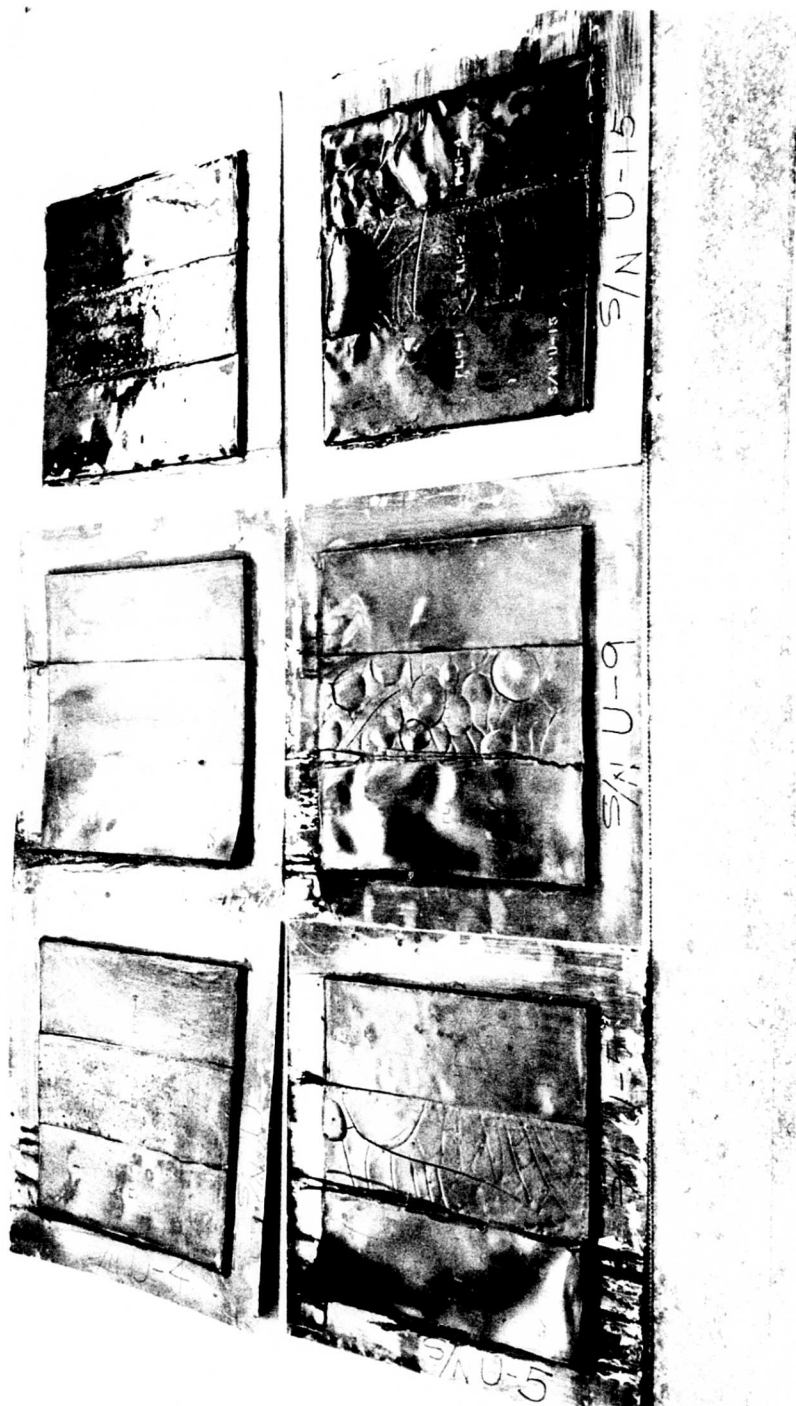
The panels in the humidity and temperature test, groups 3 and 4 (the two higher temperature test groups), were blistered and melted after 11 hr of the first cycle, and testing was stopped at this time. Photographs are shown in Figures 9, 10, 11, and 12. The panels in groups 1 and 2 (the two lower temperature test groups) completed the 75 cycles of testing. The results are shown in Figures 13 and 14 and noted in Table II.

Figure 13. Panels After 75 Cycles at 225°F (U-4, U-8, U-14 in Upper Row);
Panels After 75 Cycles at 250°F (U-5, U-9, U-15 in Lower Row).

Serial No. B-5 - Minor blistering, peeling, melting, and cracking along back section
Serial No. U-5 - Minor peeling, cracking, and melting
Serial No. B-15 - Major peeling and warping
Serial No. U-9 - Major blistering and minor peeling
Serial No. B-9 - Major peeling
Serial No. U-15 - Minor blistering and cracking
Serial No. 2 - Minor blistering and peeling

- Group 1 - S/N U-14 - Minor peeling and melting
 S/N B-14 - Major peeling
 S/N U-4 - Slight warping
 S/N U-8 - Slight peeling and melting
 S/N B-8 - Major peeling
 S/N B-4 - Major peeling
 S/N 1 - Slight peeling
- Group 2 - S/N B-5 - Minor blistering and peeling; minor melting and cracking along back section
 S/N U-5 - Minor peeling, cracking, and melting
 S/N B-15 - Major peeling and warping
 S/N U-9 - Major blistering and minor peeling
 S/N B-9 - Major peeling
 S/N U-15 - Minor blistering and cracking
 S/N 2 - Minor blistering and peeling
